TOTO

"GLORIA" SINGLE LEVER BATH & SHOWER SET TX432SG

SPECIFICATIONS

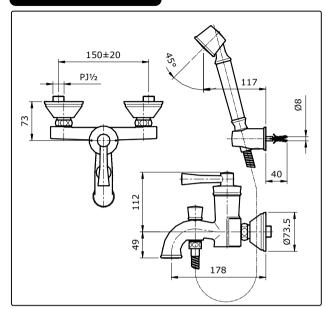
OPTIONAL HANDLE

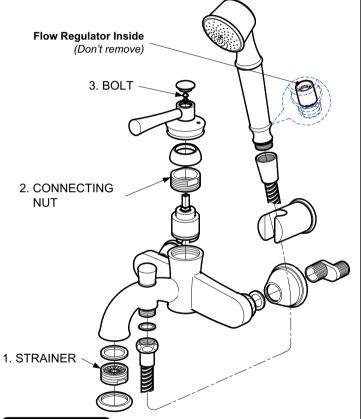
PROBLEM	CHECK POINT	SOLUTION
Flow rate unsatisfactory	1	Remove and clean
Water leaks around the handle	2	Tighten
Handle is loose	3	Tighten
